Home survey example

This is an example of a professional home survey that is centred around installing renewables in the home.

Condition Report

123 Example Street, Example, EE1
123

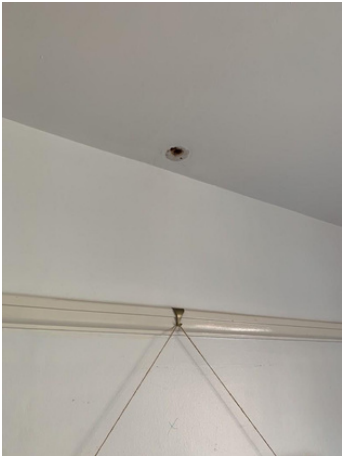
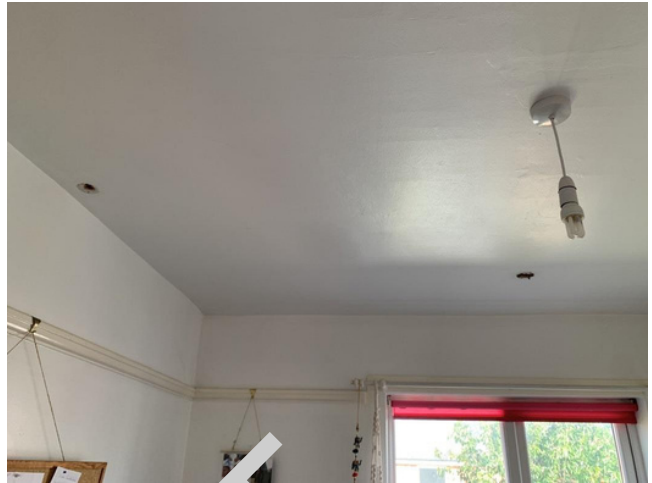
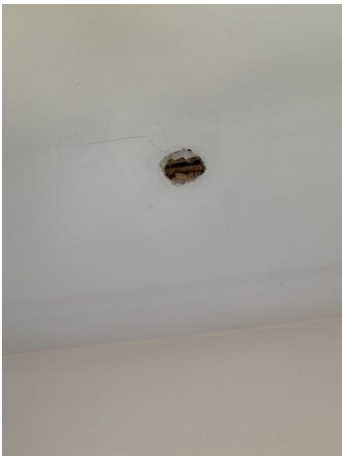
Holes in ceiling

DescriptionTwo holes in ceiling

ConditionSee photos

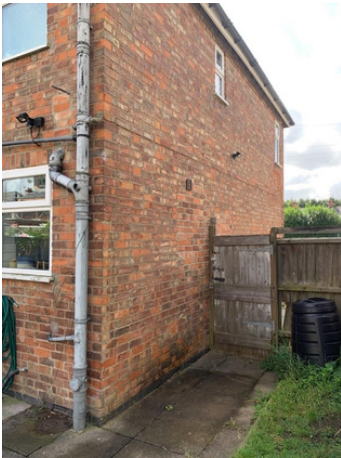
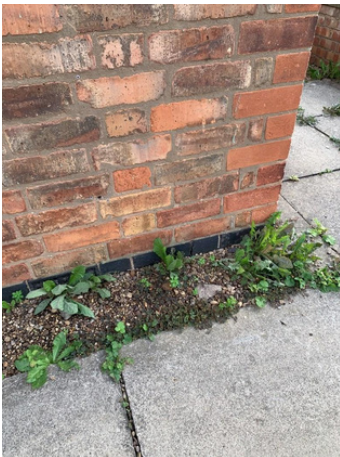
Damp proof course

DescriptionNo visible evidence of DPC

ConditionNeeds further investigation

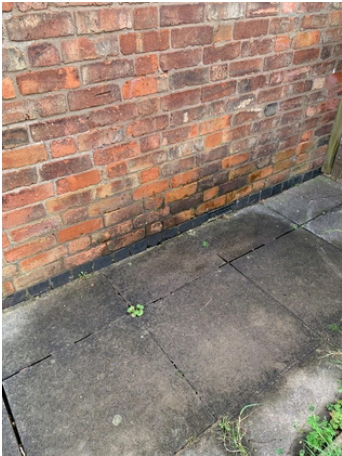
DescriptionArea of wet/damp brickwork. Ground floor side elevation towards rear

ConditionCause needs to be established

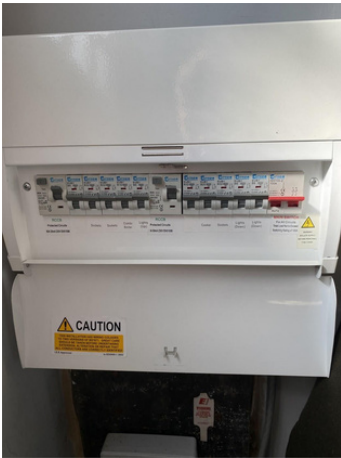
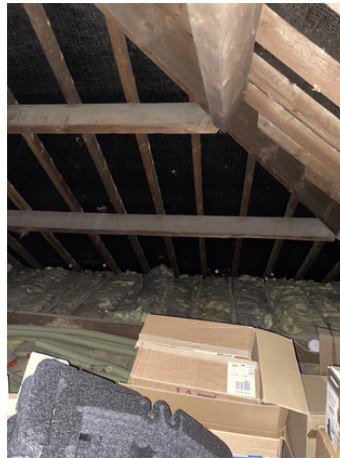
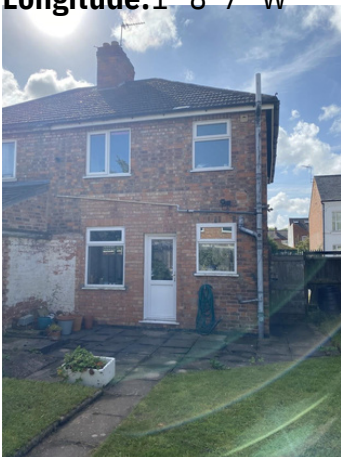
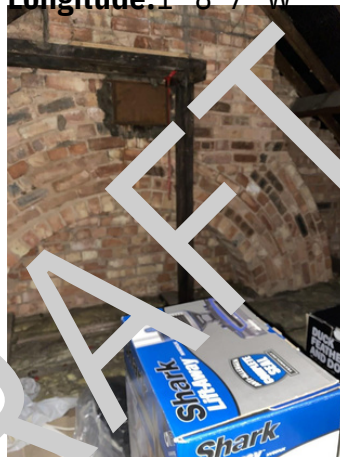
PV Assessment (1)
<p>Description Suitable orientation - Front elevation facing South Roof pitch - 35° Shading - None Obstacles - Small chimney External access - No issues Roof structure - Hipped roof. General wear and tear but no immediate issues identified.</p>
