Home survey example

This is an example of a professional home survey that is centred around installing renewables in the home.

Condition Report

123 Example Street, Example, EE1
123

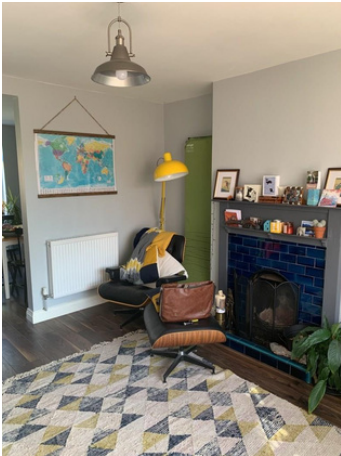
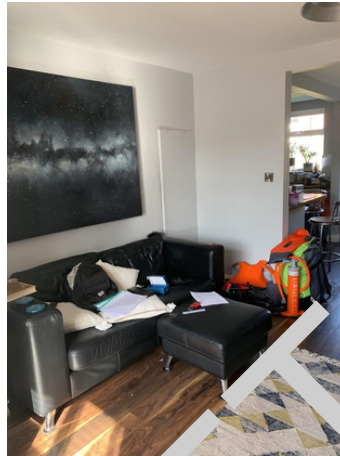
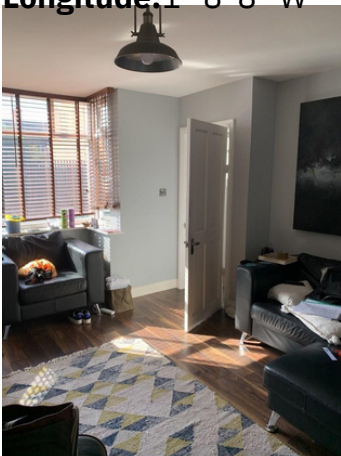
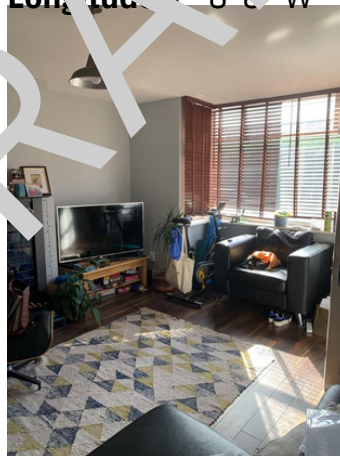
Lounge

Is this element internal or external? Internal
Condition Summary Reasonable condition

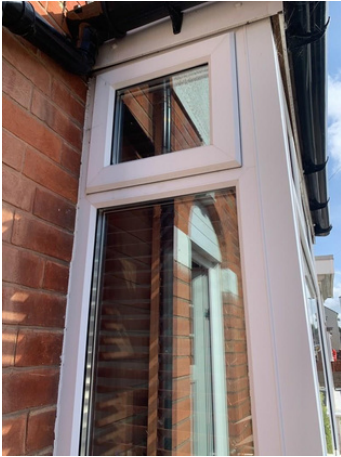
there an openable window? Yes

Do they have trickle vents? No

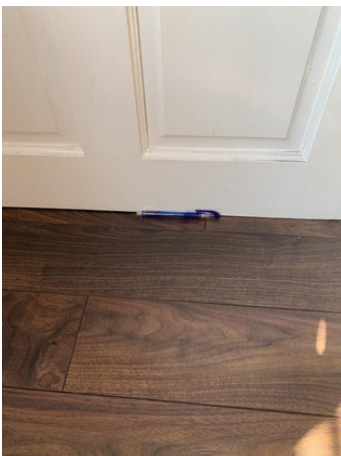
Is there an open-flued heating appliance within this room? No

Are the undercuts on all the internal doors (50mm gap on a one meter door)? No

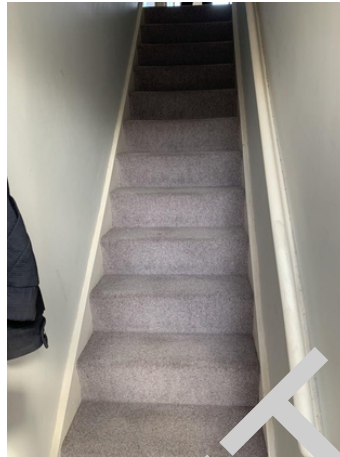
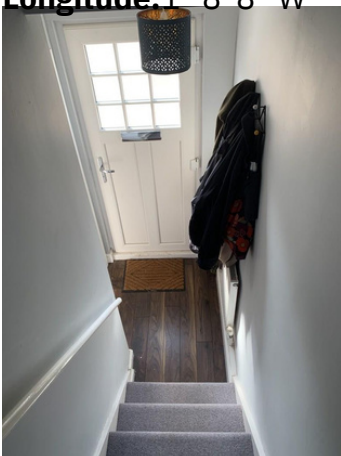
Condition Summary Good condition

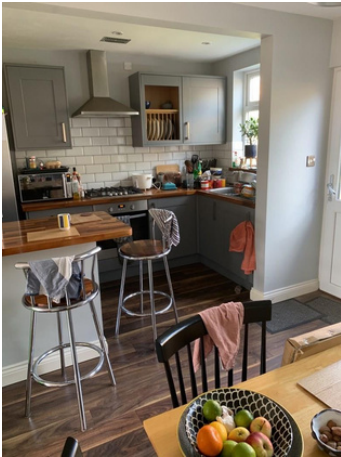
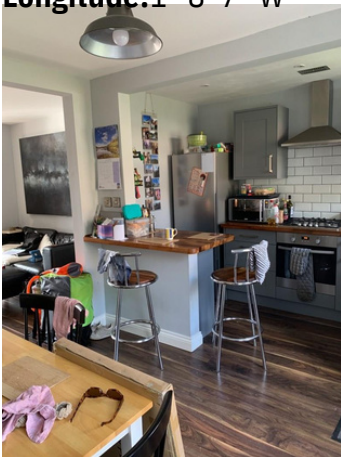
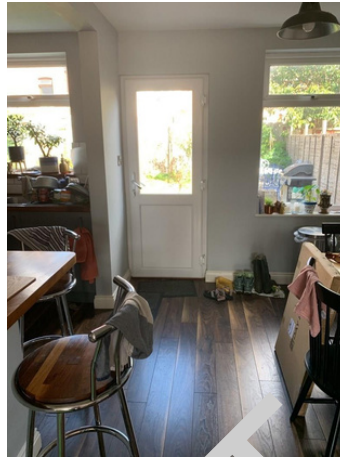
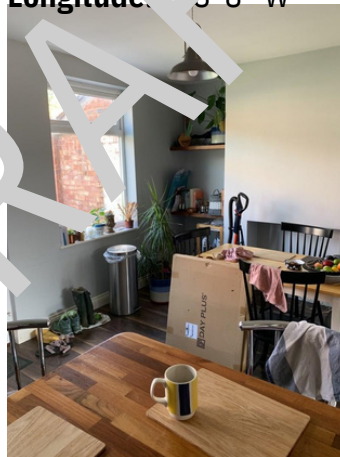
Condition Summary Good condition

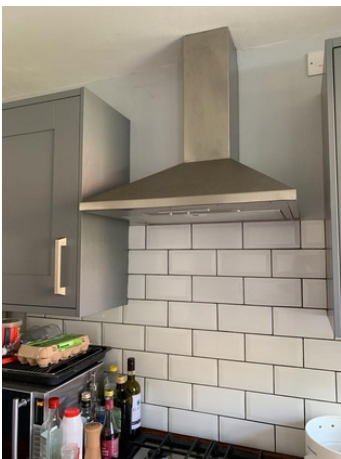
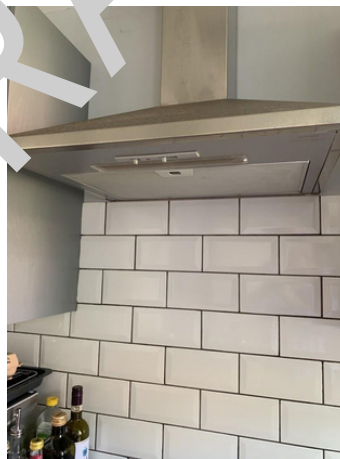
Are there any other existing ventilation systems present in this room?Yes

Do any of the ventilation systems present appear to be working?Yes

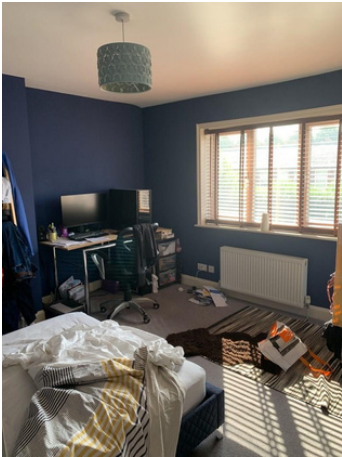
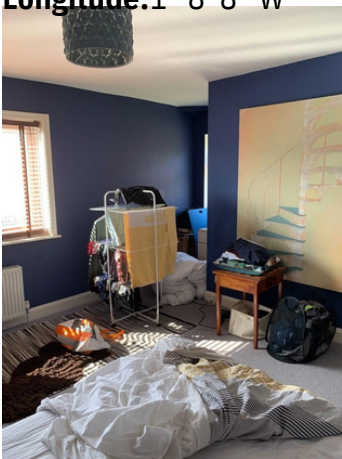
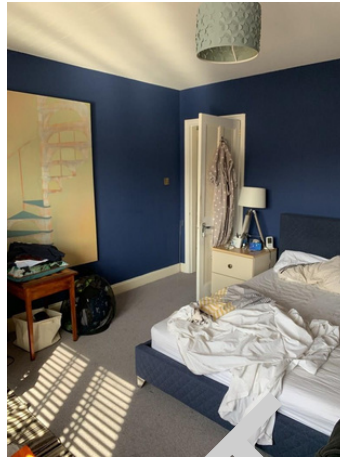
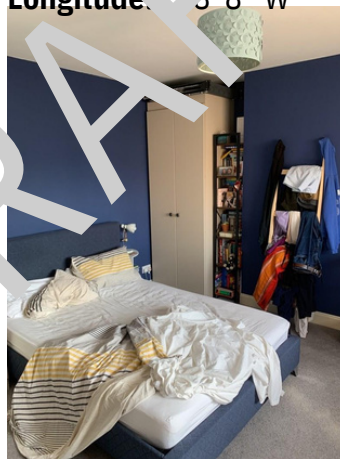
Condition Summary Reasonable condition. No concerns

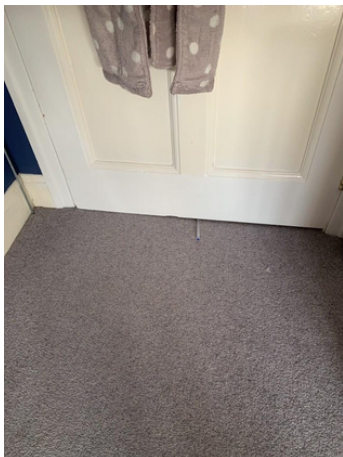
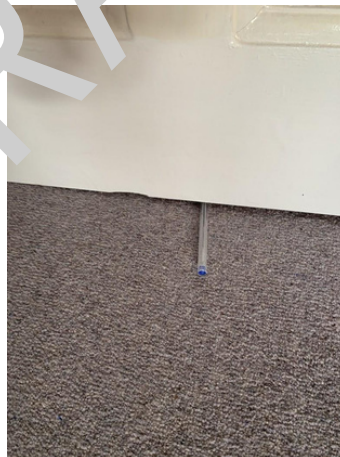
Is there an open-flued heating appliance within the room?No

Are the undercuts on all the internal doors (7.6mm gap or more meter door)?Yes

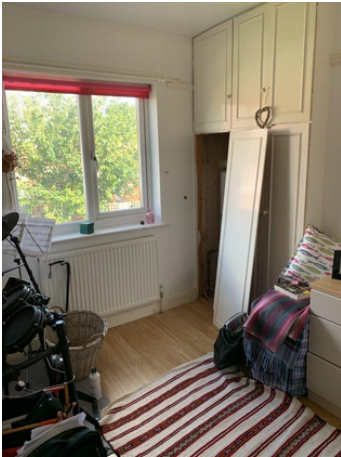
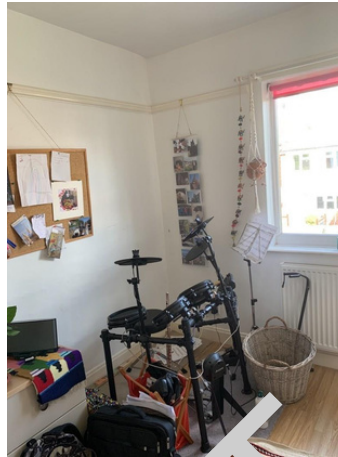
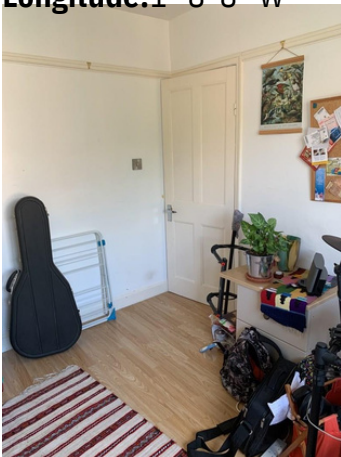
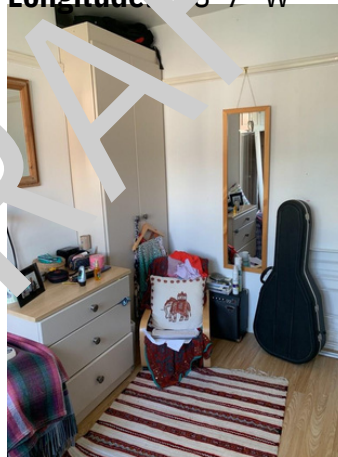
Condition Summary Reasonable condition. No concerns

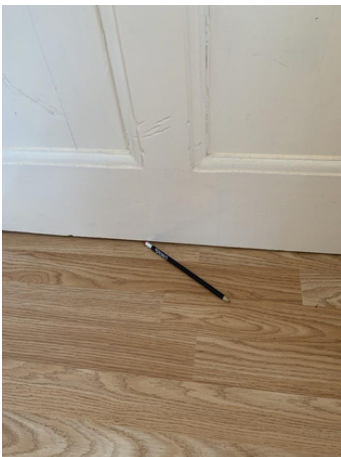
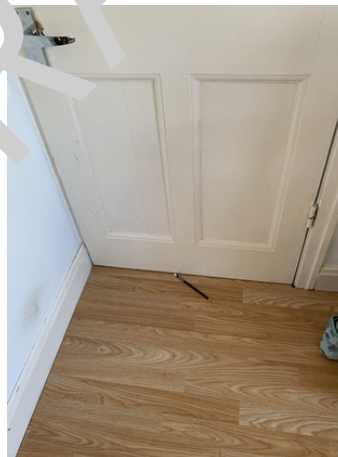
Are the undercuts on all the internal doors (7.6mm gap on one meter door)?No

Is there any evidence of condensation, damp or mould growth in this room?No

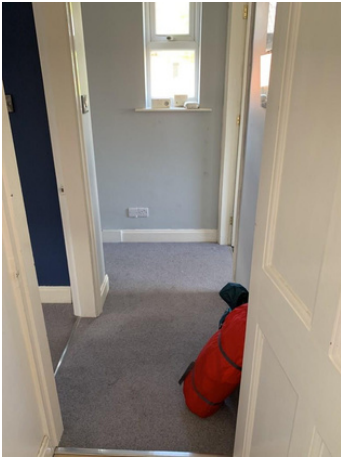
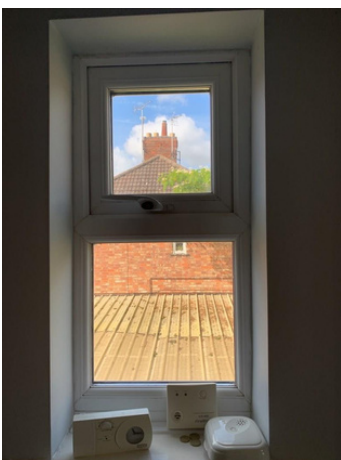
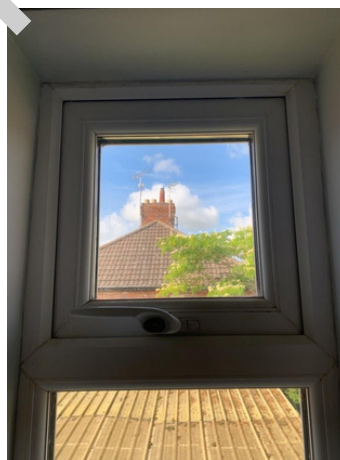
Landing

Condition Summary Good condition

Do they have trickle vents? No

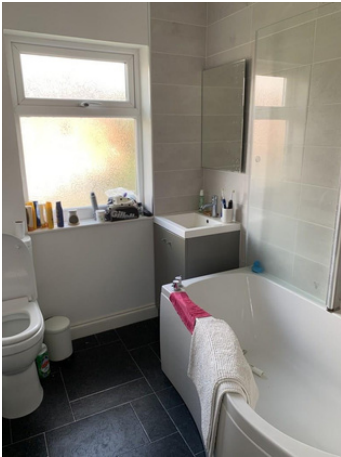
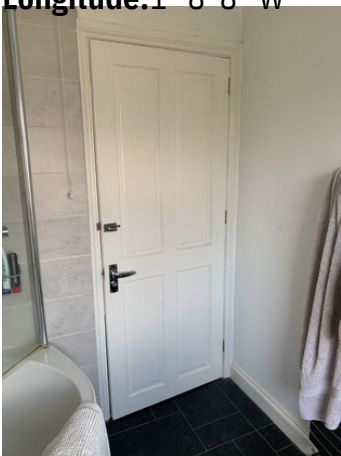
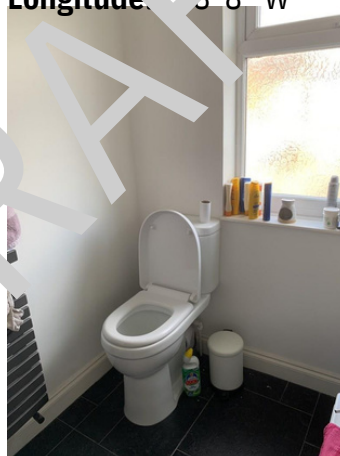
Bathroom

Condition Summary Good condition

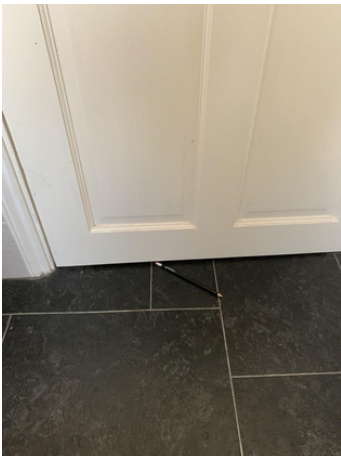
Does the room have intermittent extract fans fitted?Yes
Please give details of locations condition and photographsCeiling mounted

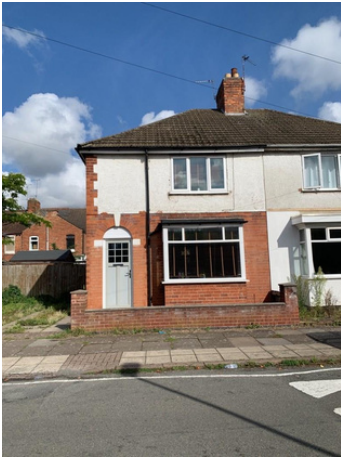
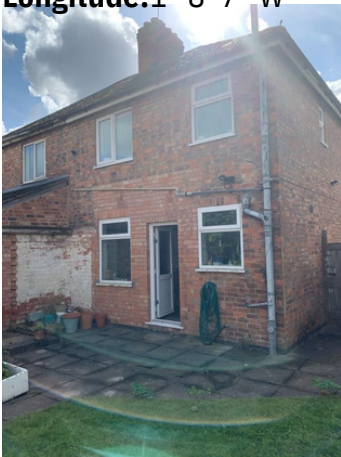
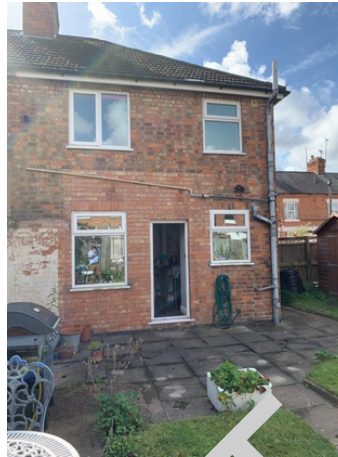
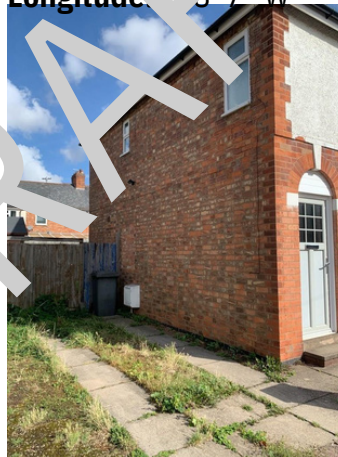
External elevation

Condition Summary Reasonable condition

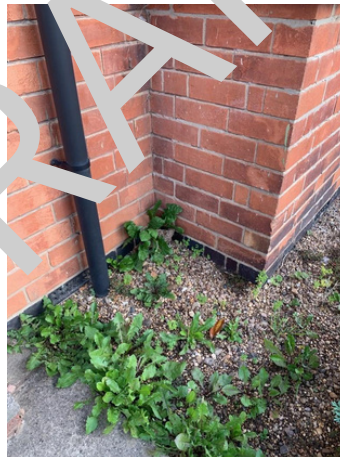
Damp proof course

DescriptionNo visible evidence of DPC

ConditionNeeds further investigation

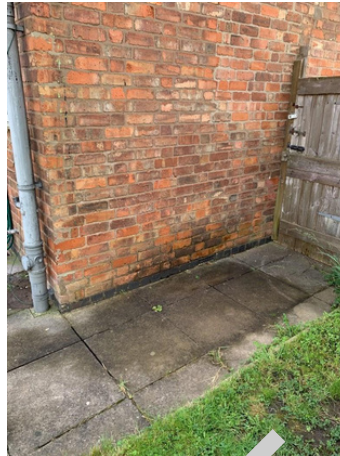
Damp brickwork

DescriptionArea of wet/damp brickwork. Ground floor side elevation towards rear

ConditionCause needs to be established

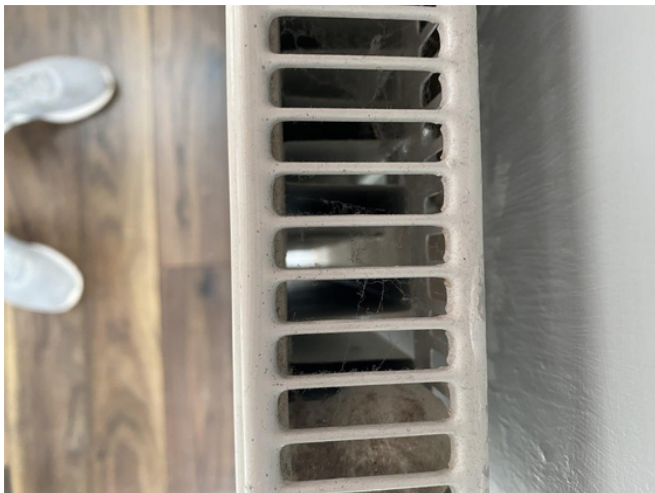
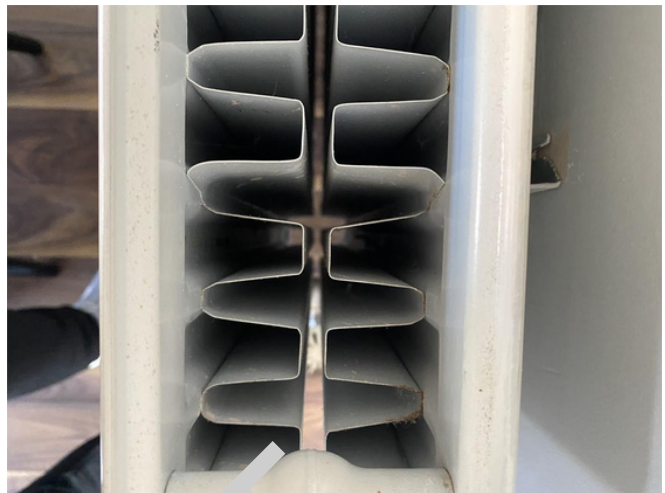
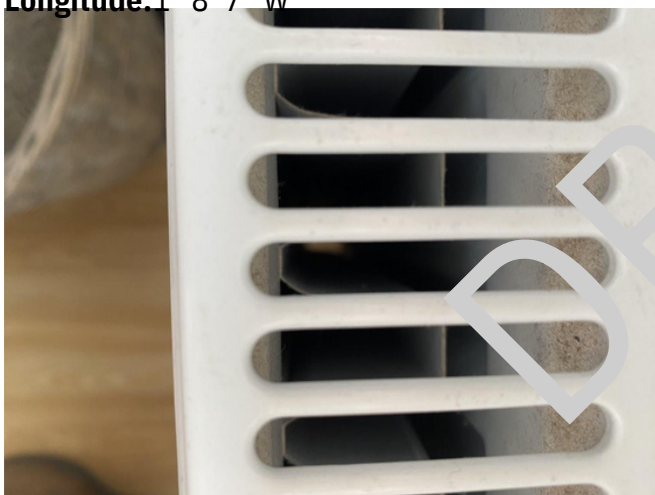
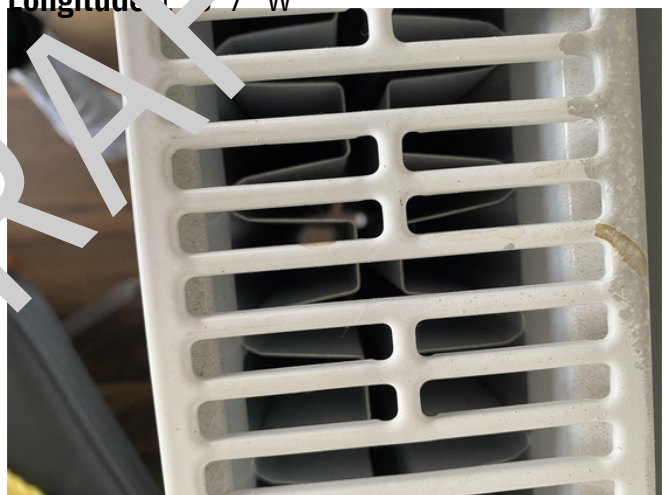
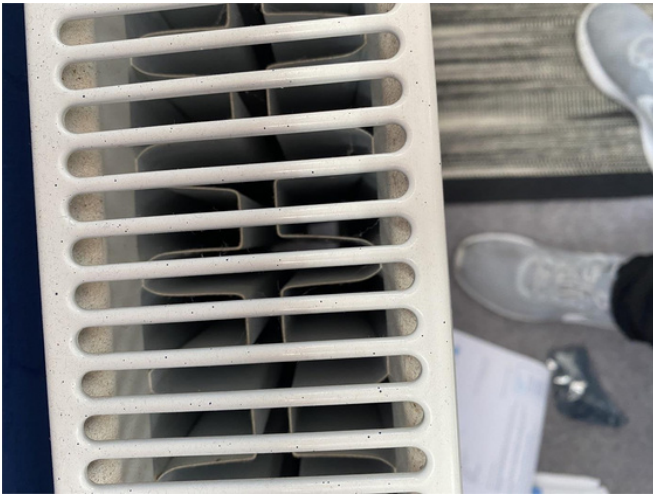
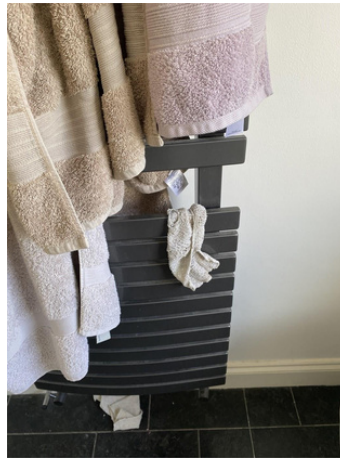
Radiators

Condition Summary Mixed

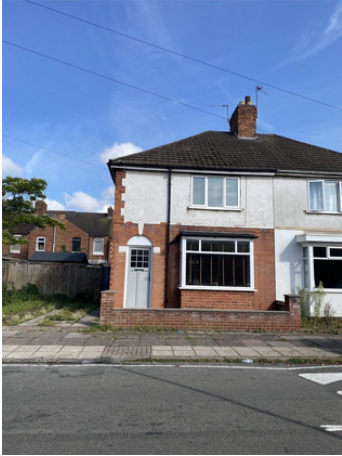
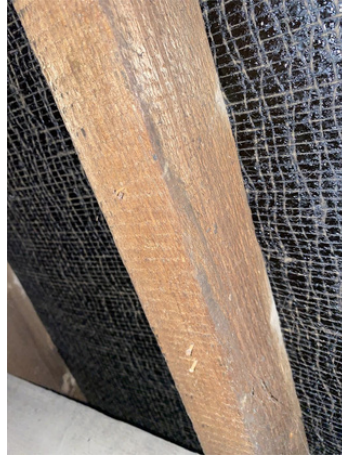
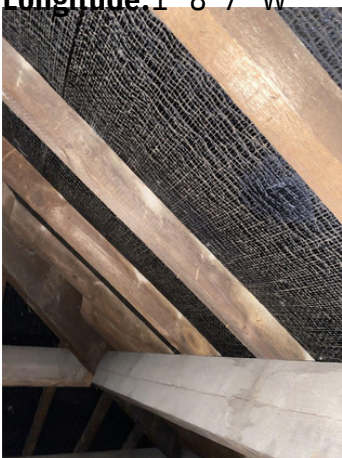
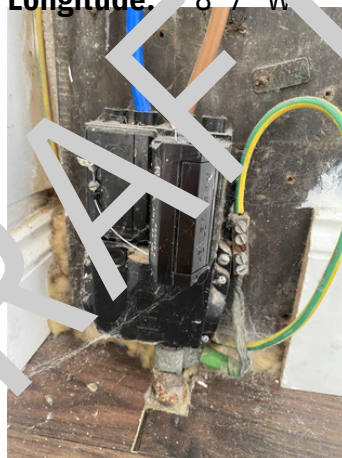
PV/Solar Assessment

PV Assessment (1)
<p>Description Suitable orientation - Front elevation facing South Roof pitch - 35° Shading - None Obstacles - Small chimney External access - No issues Roof structure - Hipped roof. General wear and tear but no immediate issues identified.</p>

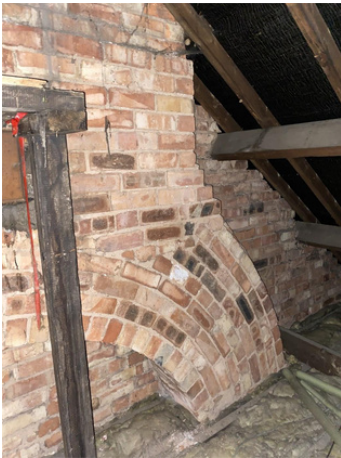
Date image taken:2023:09:13 11:35:16

Structural considerations - Ceiling joists appear in good condition. Loft floor covering would need replacing/strengthening.
